Meyers Aircraft Owners Association

GENERAL MEMBERSHIP NEWS

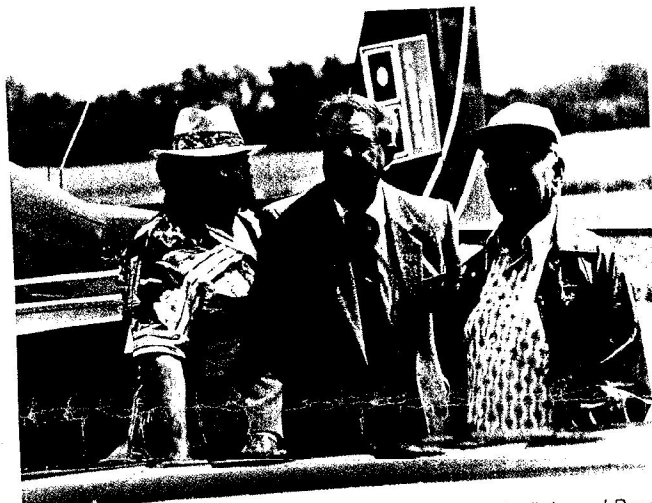
Keith Diver, Ray Betzoldt, a former Meyers test pilot, and Pard Diver, behind the wing of Tom Monaghans' Meyers N430D.P. Pard and son, Keith, rebuilt the 200B, taken from a Cincinnati hangar fire.

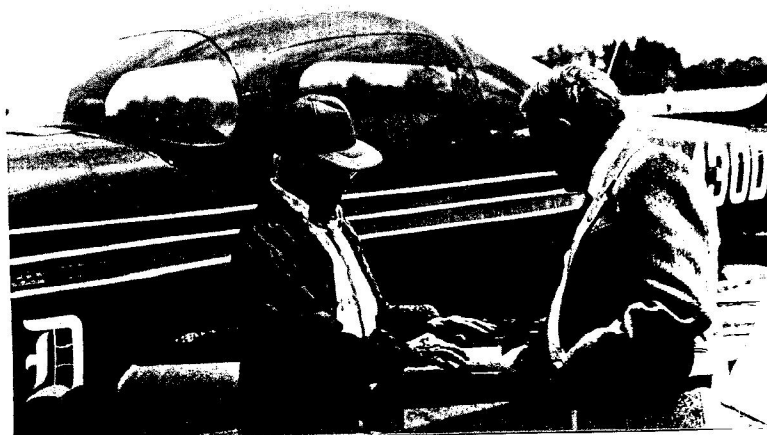
Pard and Ray Betzoldt, examine the .004" overlap of paint they contend reduced air speed by 10 mph.

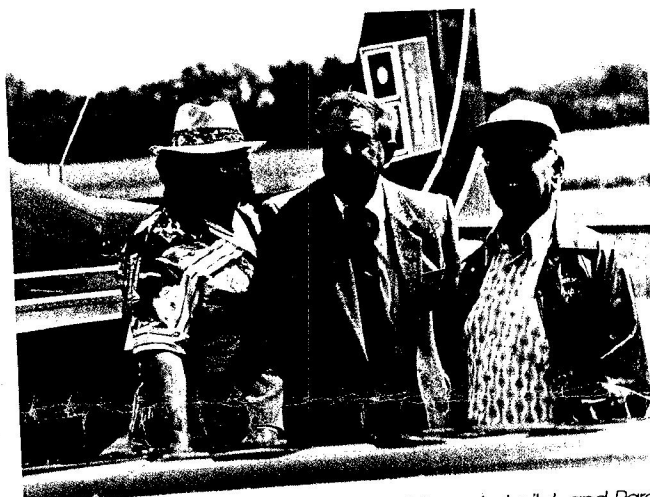
Keith Diver, Ray Betzoldt, a former Meyers test pilot, and Pard Diver, behind the wing of Tom Monaghans' Meyers N430D.P. Pard and son, Keith, rebuilt the 200B, taken from a Cincinnati hangar fire.

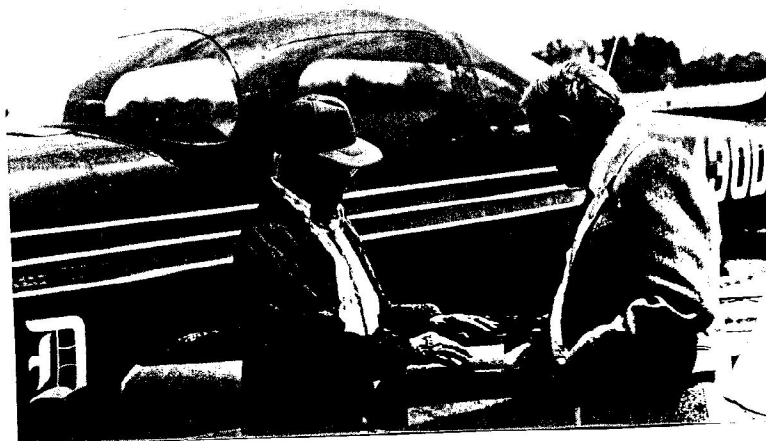
Pard and Ray Betzoldt, examine the .004" overlap of paint they contend reduced air speed by 10 mph.
