Used Airplane Guide

An airplane designer who set out to beat all competitors in speed, strength, quality and maintainability would do well to study the story of the Meyers (Aero Commander) 200. The aircraft achieved all these goals at its debut back in 1958 and even today has few peers in those respects. But range, payload and comfort were severely limited, and it failed in the one aspect that matters under the American free enterprise system: it could never turn a profit for its builders.

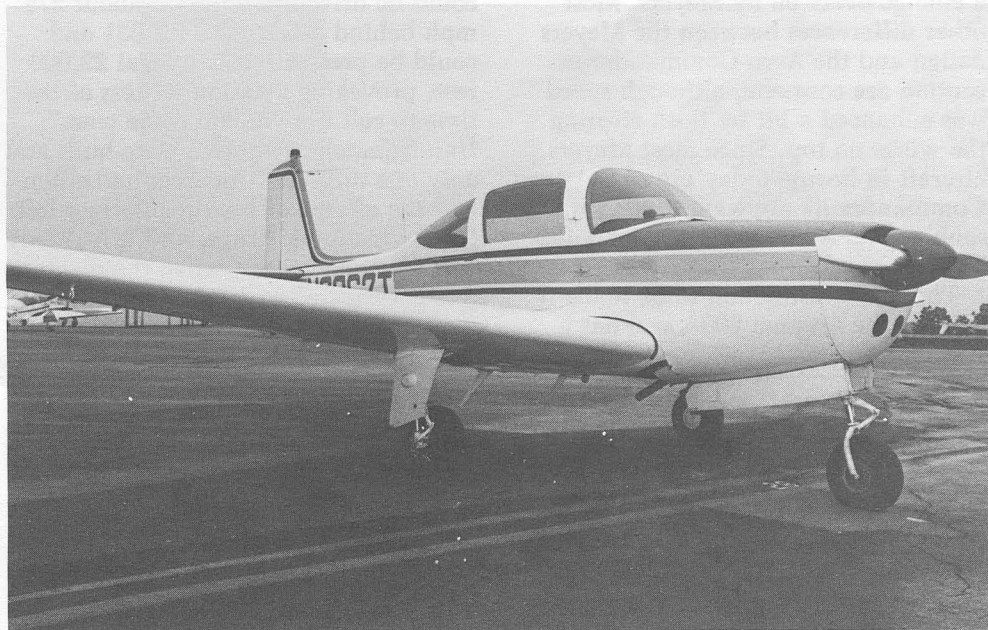
A generally slick aerodynamic package, despite the blunt nose, affords the Meyers its speed. Owners like to boast that the nosewheel is so well engineered it doesn't need a shimmy damper. Hidden beneath the smooth curves is a massive tubular framework that comprises the fuselage and cabin and the wing out to the landing gear.

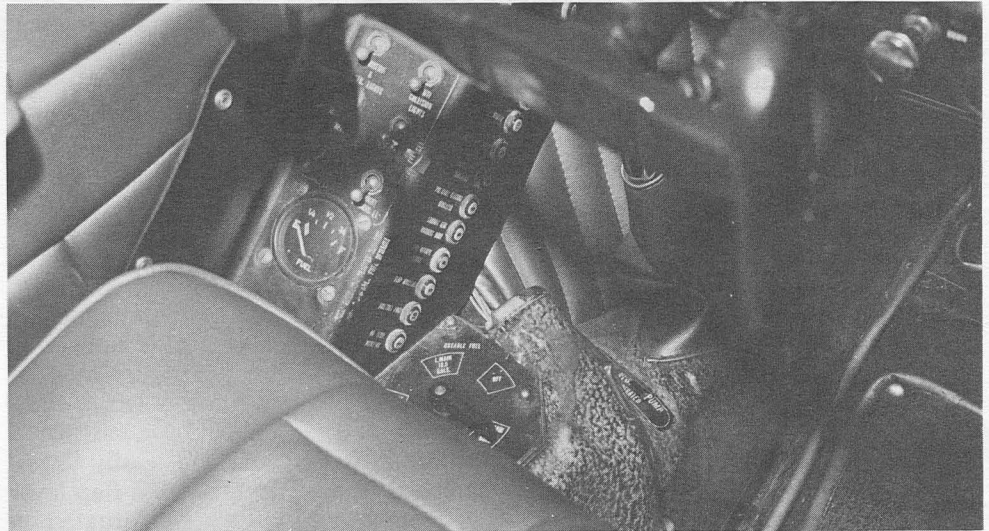
Fuel management calls for switching to four separate tanks with the lever at the left of the pilot's leg. Fuel gauge shows only the fuel in the tank selected.

Among causes for the 11 accidents, fuel system problems and fuel mismanagement top the list. In one case, a hose fitting came loose, and in another the lining of the metal-braided fuel hose sprang an unseen leak and sucked air. The grapevine of Meyers owners has spread the word, and many have replaced these metal-braided lines with ones that more readily reveal the leaks. In two other accidents, pilots ran out of fuel or ran tanks dry and killed the engine. The fuel system does require some attention, since there are four 20-gallon (18.5 usable) tanks, with a selector and a single gauge located on the left subpanel alongside the pilot's leg. On any fairly long trip, there will be two or three changes of tanks, and the only way to read the gauge for a tank is to switch to it.

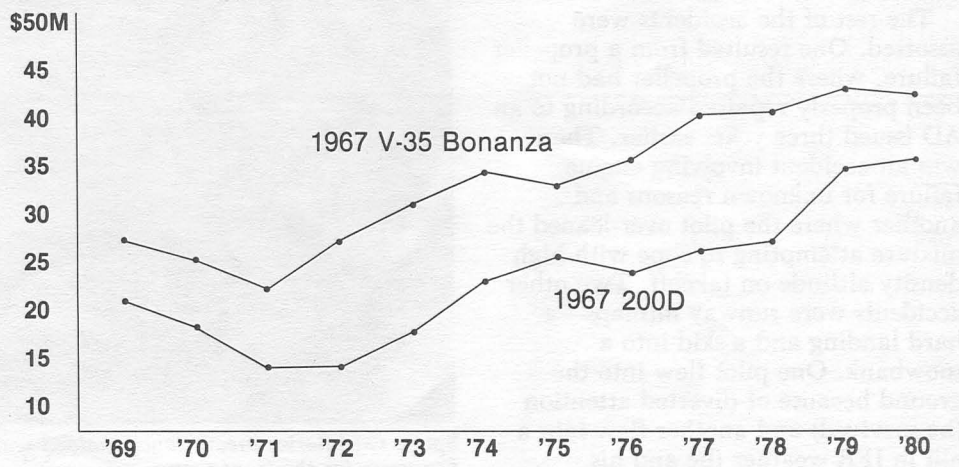
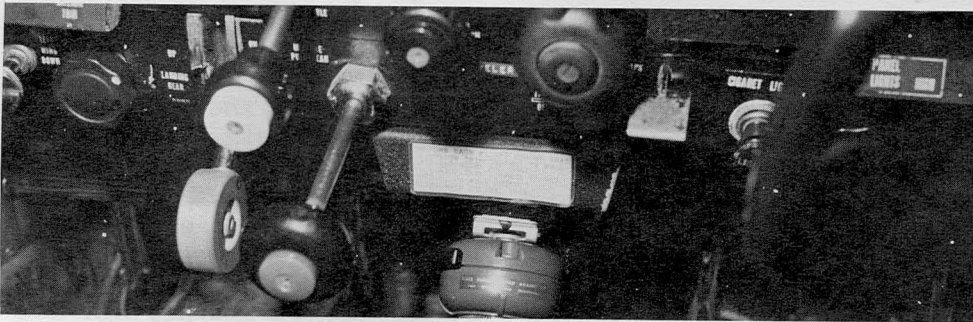
The aircraft has the luxury of both aileron and pitch trim. *The unorthodox pitch trim is the knurled vernier knob above the mike; aileron trim is located at the left of the white-tipped throttle control. Mixture is below and between throttle and prop.*

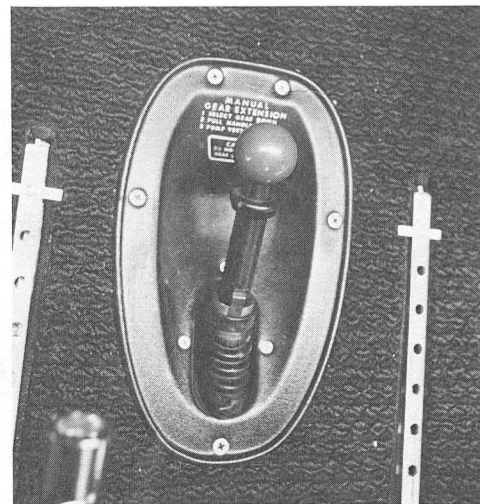
Between the front seats: an emergency gear extension pump handle. Both gear and flaps are hydraulic on the Meyers, and can be operated manually.

An engine-driven oil pump does double duty in operating the gear and extending the flaps. A wobble pump between the seats serves as a backup for this system, so only a hydraulic leak could put the whole affair out of commission. Even then, there is a free-fall procedure for the landing gear, although a no-flaps landing would be necessary.

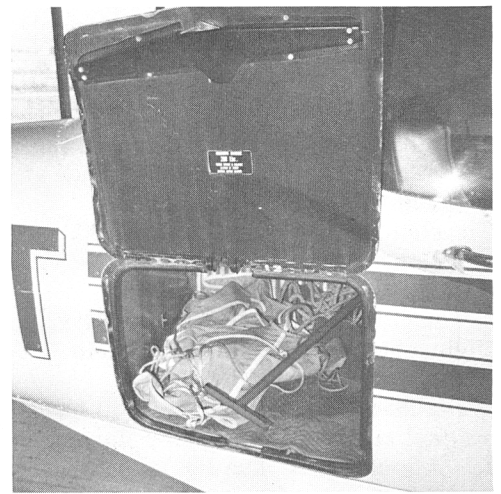
Baggage compartment holds a respectable 200 pounds structurally.

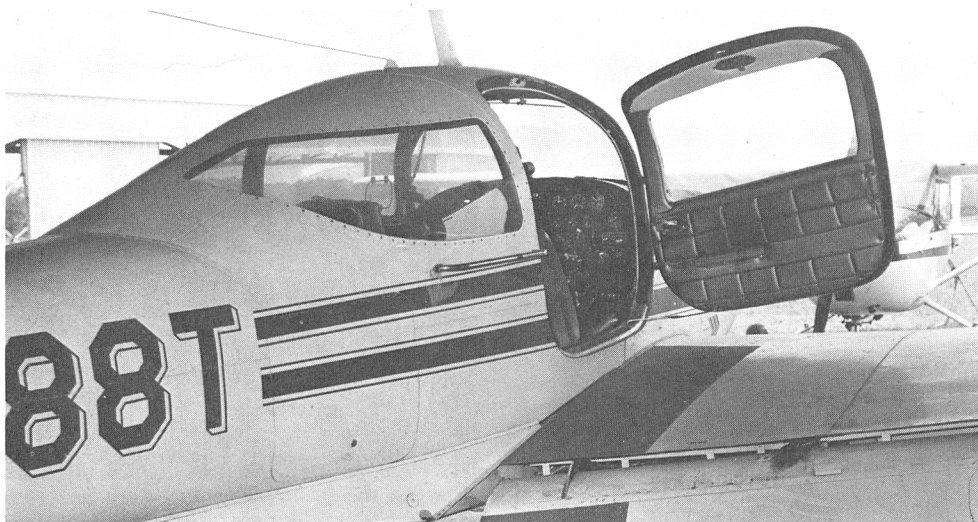
Massive bar alongside the door eases entry and typifies what operators characterize as a quality of being "overbuilt."
